"Pressure-proof test" 4L218?

Stress test

We applied to perform ^{ed} ~~the stress tests of 2.5m long~~ ^{pressure-proof test} Carbon fiber Reinforced Plastic (CFRP) pipes at 3 bar without mylar window. Therefore, ~~We~~ ^{for the} used tape to connect flange and close downstream side in order to disconnect them after the test. We explain how to set up and what we did in this ~~stress~~ test.

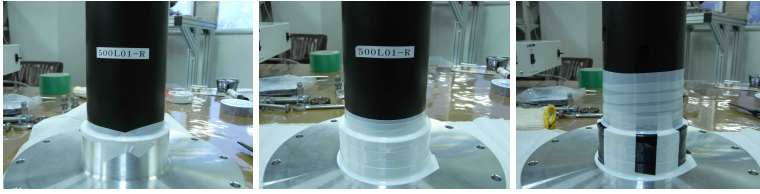
Picture 3:

We put some layers of tape to seal a small gap between the flange and the CFRP pipe.

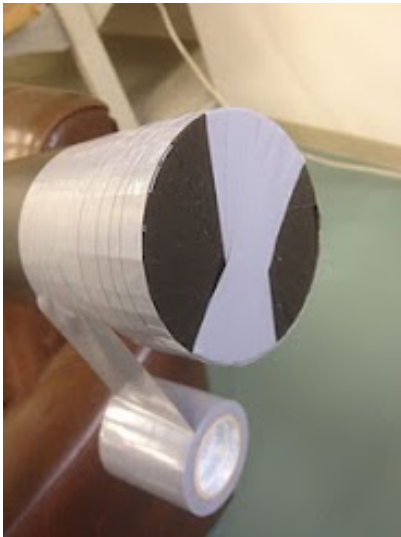
Picture 4:

It was very difficult operation to seal a ~~leak by tape only~~ in the downstream side. ^{With tape} At first we made bridges with tape changing its angle and put tape along the circumference of the pipe (Picture 4). We repeated ~~to put tapes~~ until the leak level is low enough. ~~The leak was checked by~~ ^{the procedure} pressuring inside pipe, ~~leak tightness was confirmed.~~

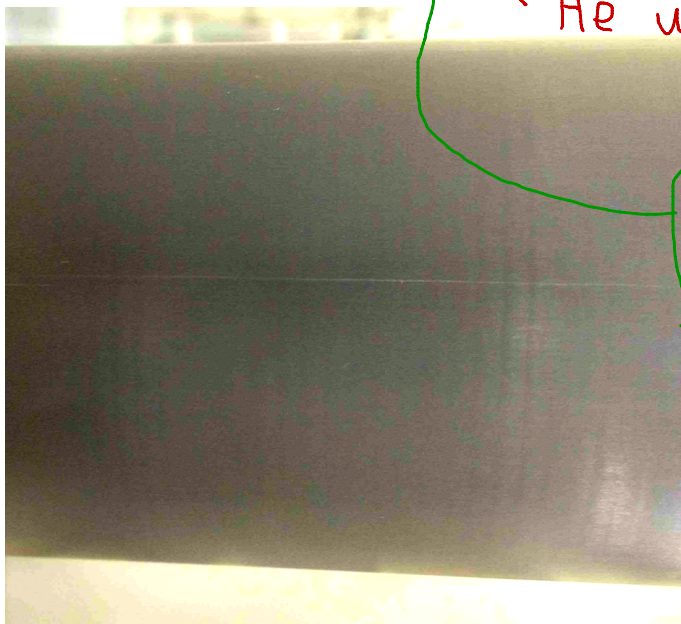
Picture 7:

Therefore outside test was attempted instead. After one minute in the first attempt of pressurizing outside, Nukazuka listened a sound something broken and he stopped the test. A white line, which ~~was~~ ^{is} 1 m long ^{running} from 50 cm far from the downstream edge, was found (see Picture 7).

After these tests we decided to use a support flange in the downstream side, ~~that is used for silver coating~~, to avoid additional mechanical stress to the pipe during the operation of putting the tape (see picture below).

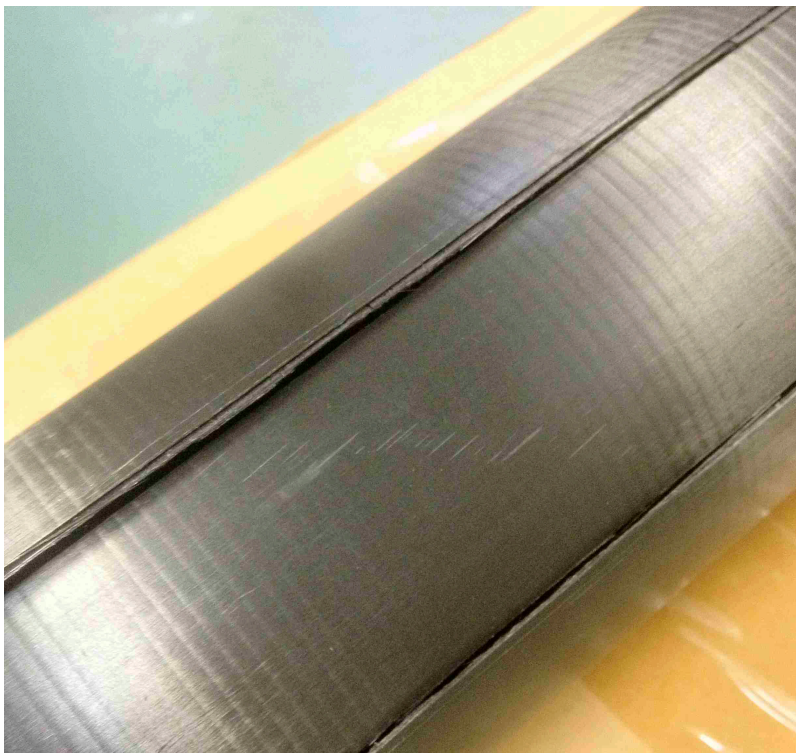
Picture 8 :

After the test in January 20 the pipe was kept as it was. Leak of the pipe 2580L03 was checked using soapy water and no leak was found. After that, inside test was succeeded without any problems. However outside test was attempted ~~as well~~, they listened another sound from the pipe in ~~the first pressurization~~. They stopped the compressor and released the pressure. They tried pressuring again. And then the pipe was broken with a big noise after 30 seconds (see Picture 8).
